# Elk Grove Village, Illinois Salt Creek Pipeline Inspection

## OVERVIEW

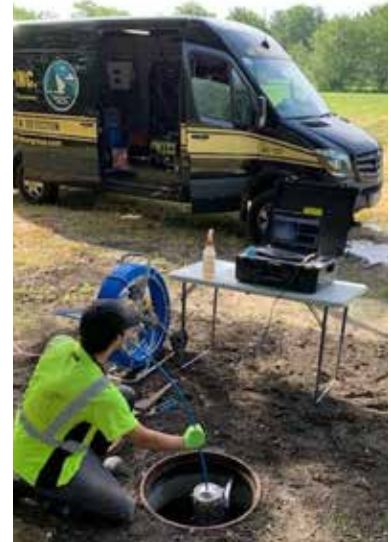
The multiparameter tethered inspection tool is lowered into 12 inch main
