# Early Main Break Notification Allows Buffalo Grove to Fix Leak Ahead of Major Blizzard

## OVERVIEW

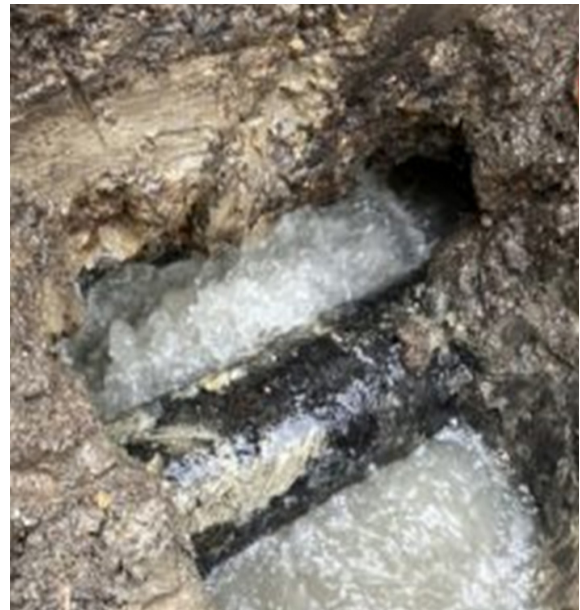
8" cast iron pipe burst identified by Aquify's 24/7 Control Center

Early morning on a cold January, Aquify's 24/7 control center identified a 130 gallon-per-minute (GPM) flow increase in Buffalo Grove's North zone. The Aquify team quickly contacted the village's water manager, Ben Kruse, alerting him of the leak and providing a localized search area for his team to investigate. The weather reports had been forecasting one of the largest snowstorms in years to hit the area later that day. After a short investigation, the village's public works team was able to locate surfacing water from the break in a culvert along the side of a busy road. When the pipe was uncovered, they discovered a beam break on an 8" cast iron pipe which they immediately repaired.

Because the 130 GPM leak was quickly identified, Buffalo Grove's team was able to excavate and repair it before the storm came in.
